# TRENTON RESERVOIR

## NJ 00560

PHASE 1 INSPECTION REPORT  
NATIONAL DAM SAFETY PROGRAM

Name of Dam: Trenton Reservoir Fed ID# NJ00560

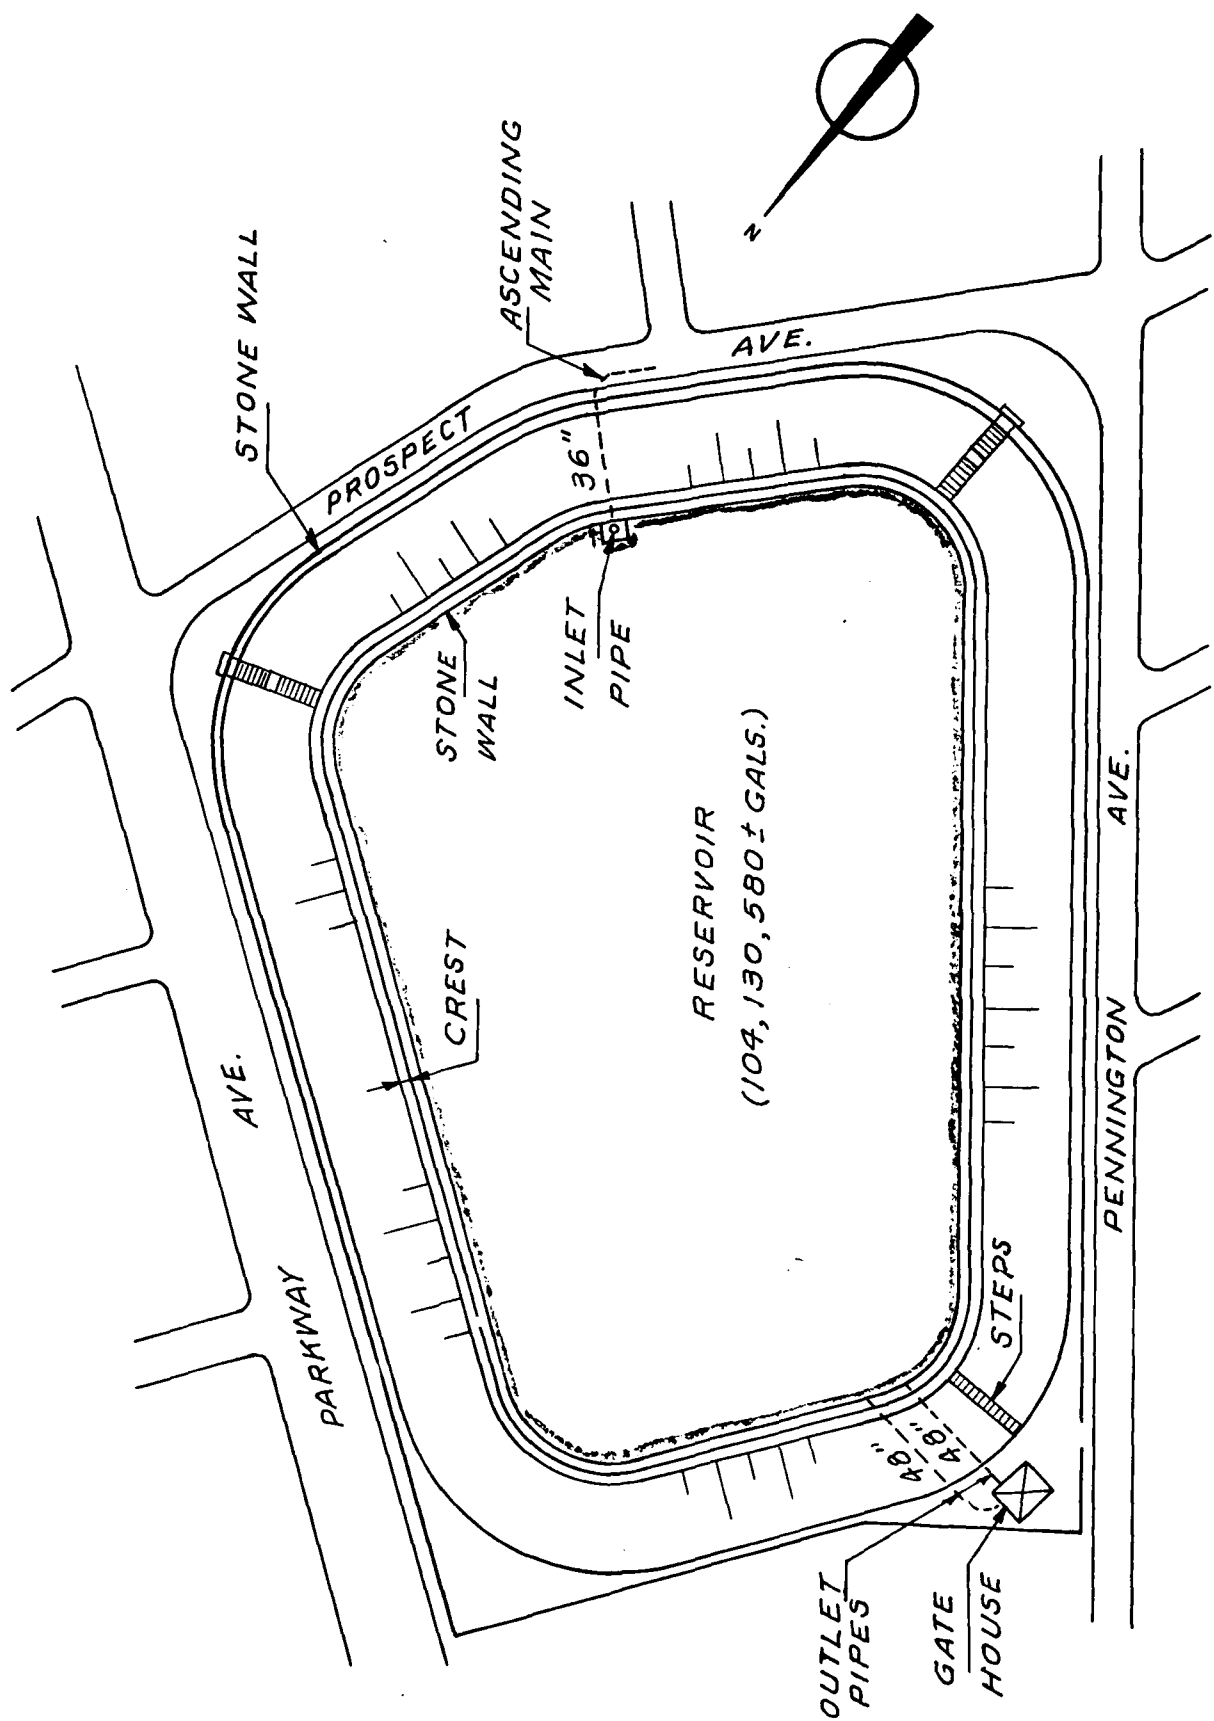
FIGURE 2

PLAN  
NOT TO SCALE

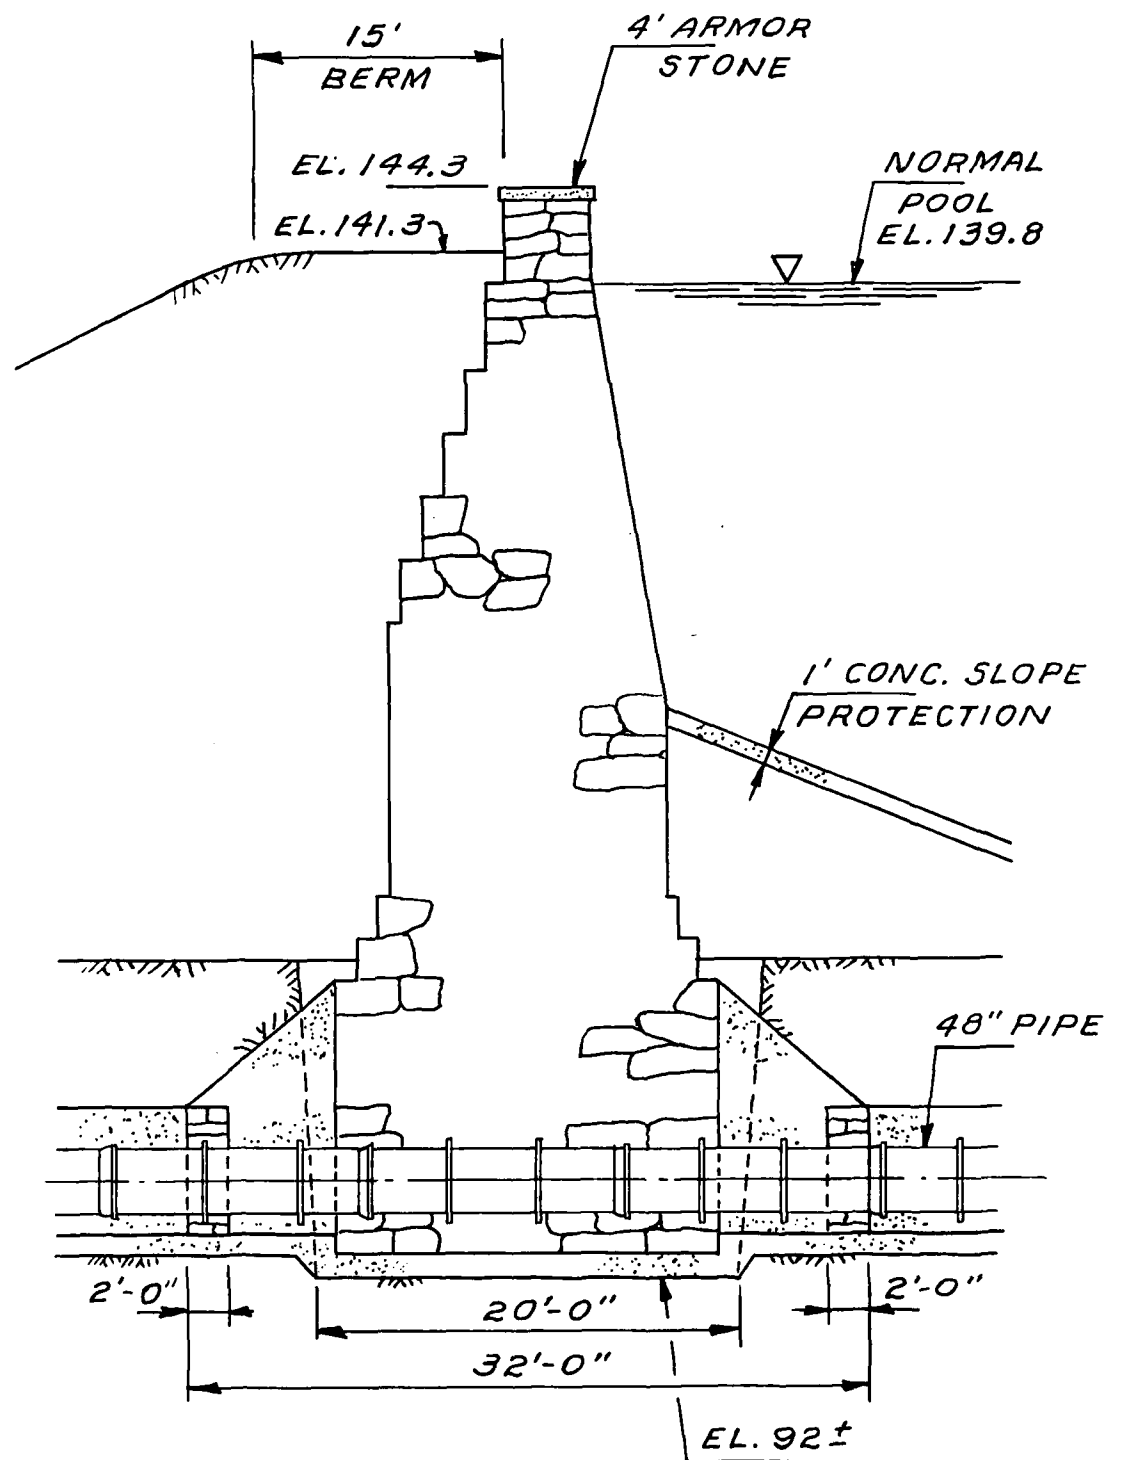
FIGURE 3

WALL SECTION  
NOT TO SCALE
